## Case Report

# Inflammatory Pseudotumor Causing Deep Vein Thrombosis After Metal-On-Metal Hip Resurfacing Arthroplasty

**Abstract:** Metal-on-metal hip resurfacings have recently been associated with a variety of complications resulting from adverse reaction to metal debris. We report a case of extensive soft tissue necrosis associated with a huge pelvic mass causing extensive deep vein thrombosis of the lower limb secondary to mechanical compression of the iliac vein. This is a rare and unusual cause of deep vein thrombosis after metal-on-metal hip resurfacing arthroplasty. **Keywords:** hip resurfacing arthroplasty, pseudotumors, DVT.

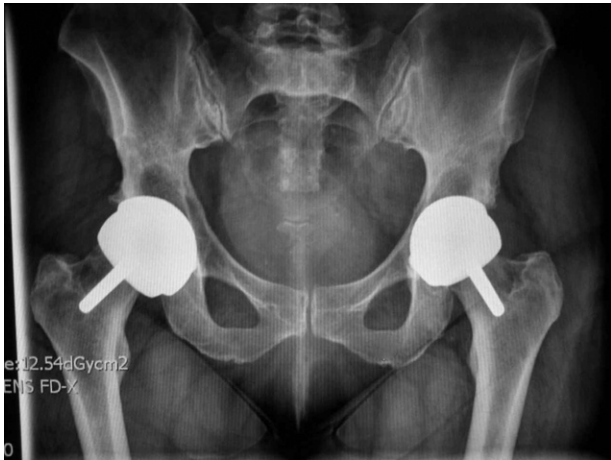
**Fig. 1.** Anteroposterior pelvis showing bilateral BHR implants.

On her laboratory workup, she had mildly elevated erythrocyte sedimentation rate of 48 mm and C-reactive protein of 37 (normal, <5), whereas her white blood cell count was 7.6 ( $10^5$ ). She had raised D-dimers. She was admitted to the hospital, and further investigations were carried out. A plain radiograph of her pelvis showed bilateral Birmingham hip resurfacing implants in satisfactory alignment (Fig. 1). There were some changes noted in the femoral neck region on left side (Fig. 1). A Doppler ultrasound of the lower limbs revealed thrombosis of the deep veins in the thigh extending into the pelvis. A venogram of left limb was performed, which showed extensive thrombosis of the deep vein of calf and thigh with thrombus extending into left iliac vein. An external compression of the iliac vein was noted on the venogram in the pelvis. There was no thrombus proximal to that

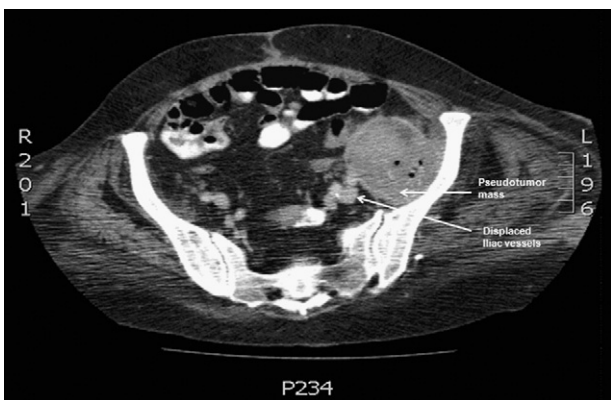
**Fig. 2.** Computed tomographic image showing large tumor in left hemipelvis compressing the vascular structures.

specific point. An ultrasonogram and a computed tomography were carried out to further evaluate the intrapelvic organs, which revealed a large complex mass in the left hemipelvis with mixed solid and cystic characteristics. The computed tomography showed this mass to be extending from the iliopsoas muscle toward its insertion into the femur (Fig. 2). The dimensions were approximately 7.3 × 5.7 cm. The exact caudal extent was obscured because of the metal artifact from hip implants. The mass was shown to be abutting against the left iliac vein causing external compression of the vessels.

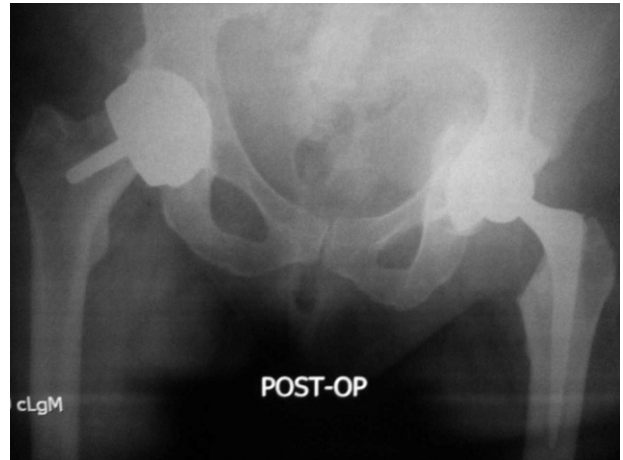
**Fig. 3.** Anteroposterior pelvis after revision left THA with trabecular metal shell and cemented Exeter stem.

Because of the persistence of her hip symptoms, she was offered a conversion to a conventional total hip arthroplasty (THA). Her case was also discussed with colorectal team, and because of the proximity of pseudotumor to the major vessels, it was deemed inoperable and because the histology confirmed an inflammatory mass, a decision was made not to excise it. A revision left THA was finally carried out through posterior approach using ceramic bearings. Intraoperatively, extensive soft tissue fibrosis was identified within the joint. All the short external rotators were replaced with fibrotic tissue. All the fibrotic tissue around the joint was extensively excised and sent for histology and microbiology analysis. The acetabular implant was removed using Explant Acetabular Cup Removal System (Zimmer). There was a segmental defect in the medial wall that was bone grafted using fresh frozen allograft. The acetabulum was reconstructed using trident multihole cup and cemented Exeter stem with ceramic bearings (Stryker) (Fig. 3). Her culture and sensitivity results were negative, and the histology was again consistent with aseptic lymphocyte-dominated, vasculitis-associated lesion. Post-operatively, her chromium and cobalt levels dropped to 105 and 68.2 nmol/L, respectively. Subsequently, she also completed her course of anticoagulants, and a repeat sonogram revealed patent deep venous system of left lower limb. Her symptoms have significantly improved, although she still complains of occasional hip pain, but she is able to carry out most of her daily activities.
